FORM B – BUILDING

Town/City: Chelmsford**Place:** (*neighborhood or village*): Old Chelmsford Garrison House Association**Photograph**

**Address:** 105 Garrison Road**Historic Name:** McCormick Craft Center**Uses:** Present: educational building

INVENTORY FORM B CONTINUATION SHEET

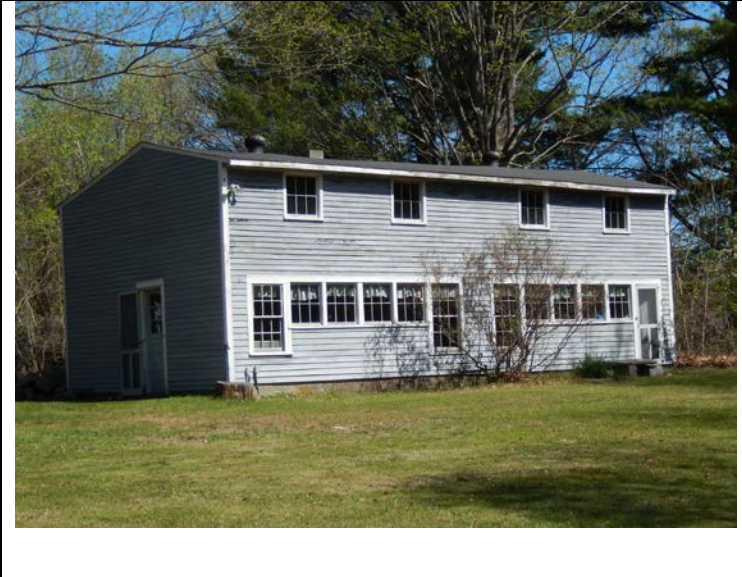
The two-story building has a stone foundation, walls clad in wood clapboard with wood trim, and a slightly-pitched side gable roof. The building features narrow wood corner boards. Fenestration throughout the building includes six-pane fixed casement and six-over-six double-hung windows. The primary (south) façade includes two ribbons of six-pane windows on the first story. The set on the west bay are flanked by double-hung windows; the east bay has a double-hung window on the west side and a pedestrian door on the east side. Four single, six-pane casement windows are on the second story. The west wall includes a pedestrian door near the center of the first story.
