# FORM F - STRUCTURE

Assessor's Number USGS Quad Area(s) Form Number
Westford H CLM.972
Town/City: Chelmsford
<b>Place</b> (neighborhood or village): Garrison House Association
Address or Location: 105 Garrison Road
Name: Town Common flagpole
<b>Ownership:</b> ☐ Public
Type of Structure (check one):
boat or ship pound canal powderhouse carousel street dam tower fort tunnel gate wall kiln windmill lighthouse X_other (specify) flagpole
Date of Construction: 1903
Source: research from Garrison House Association
Architect, Engineer or Designer: unknown
Materials: wood pole
Alterations (with dates): 2013 Relocated to current site and shortened
Condition: Fair
Moved: _□_ no ⊠ yes Date: 2013
Acreage: N/A
<b>Setting:</b> The flagpole was relocated to the Garrison House Association property and currently stands to the east of Hil Jock House and north of the Garrison House.

105 GARRISON ROAD

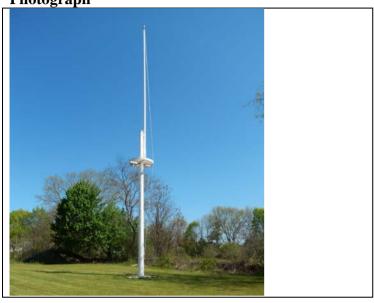
**Photograph**

The flagpole is a solid wood, painted pole that was originally used as a ship mast. The pole was shortened by approximately one-third when it was relocated to the site in 2013. It is set in concrete with a small gravel surround. Pegs on the sides of the pole permit access to a small, grated landing. A second narrower wood pole is attached to the top of the pole. Metal flagpole hardware and rope were installed on the mast for it to be used as a flagpole.
