# FORM B – BUILDING

**Town/City:** Chelmsford

**Address:** 105 Garrison Road

**Historic Name:** Summer Kitchen

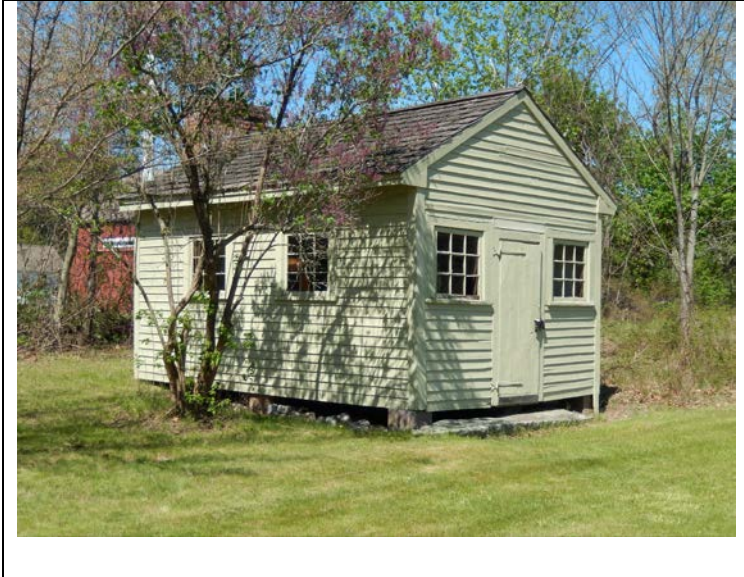
## Photograph

The one-story summer kitchen building has a pier foundation, walls clad in wood clapboard with wood trim, and a slate shingled front gable roof. An external brick chimney is centrally located along the rear (west) wall. Fenestration in the building consists of nine-pane wood casement windows. The primary (east) façade is three bays wide with the entry in the center flanked by casement windows. The entry features a vertical wood plank door with iron hinges. The north and south walls each feature two windows. The interior of the kitchen is an open space with a timbered ceiling, wood floor, and wood wainscoting. The hearth is at the rear of the room.

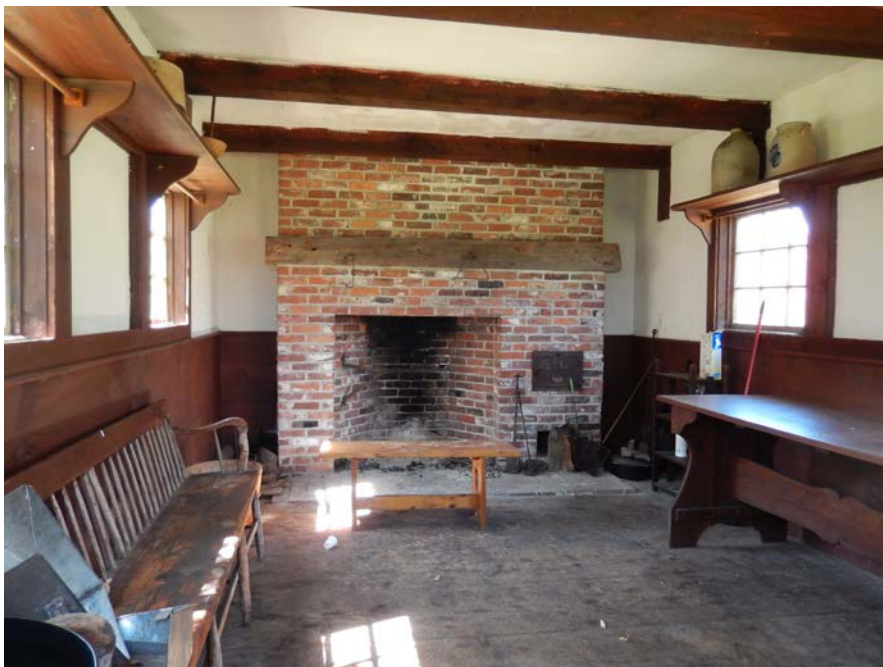
Interior of summer kitchen showing fireplace. May 2016.
