FORM B – BUILDING

Town/City: Chelmsford

Address: 264 Groton Road

Historic Name: Samuel and Lillian Farrow House

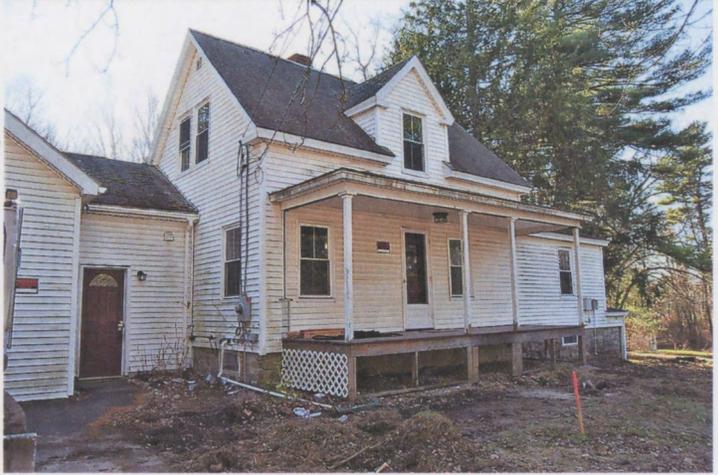
View looking southwest toward facade.

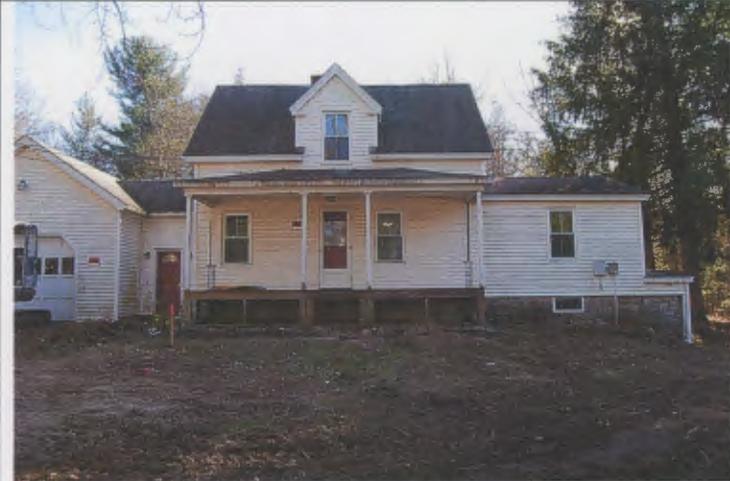
View looking south toward façade. Garage addition visible at left. The recessed door at left is part of the garage addition.

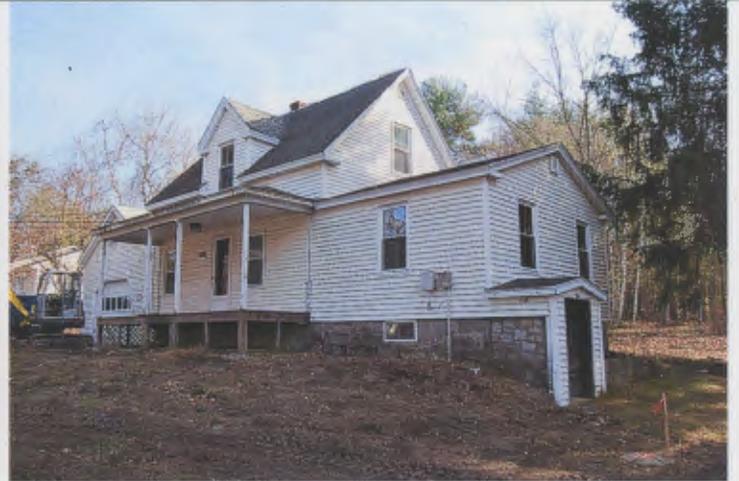
View looking southeast toward façade. Note different manners of masonry construction among the main block, ell and shelter.

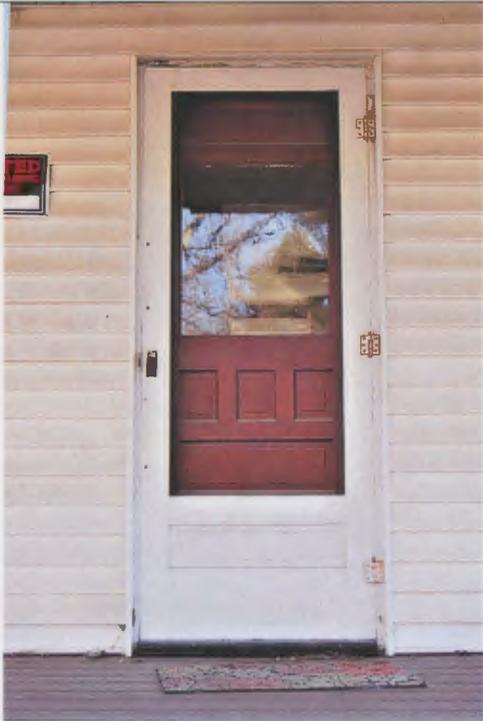
Façade door.

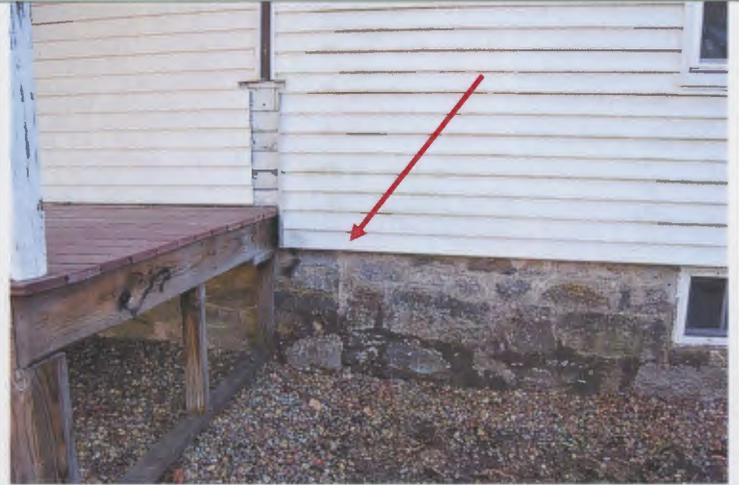
View looking southeast toward façade. Removal of porch post provides view of clapboard underneath the vinyl siding. Joint in stone foundation identifies that the west ell was added after the construction of the main block.

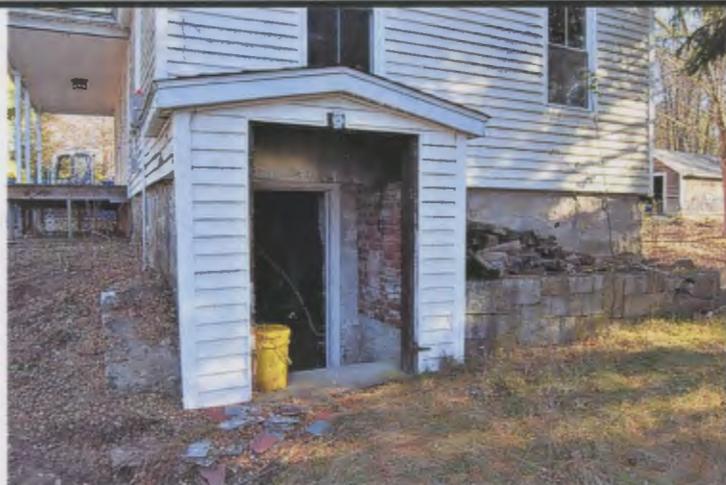
View looking east toward basement entrance.

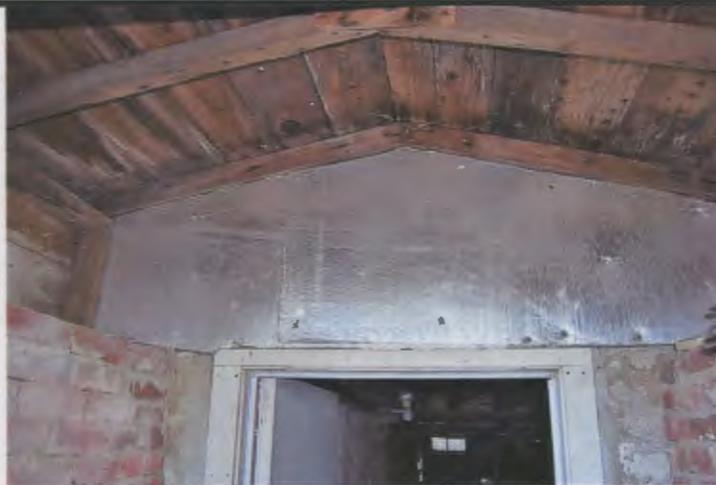
View looking east toward bead board ceiling of basement entrance. Note brick walls.

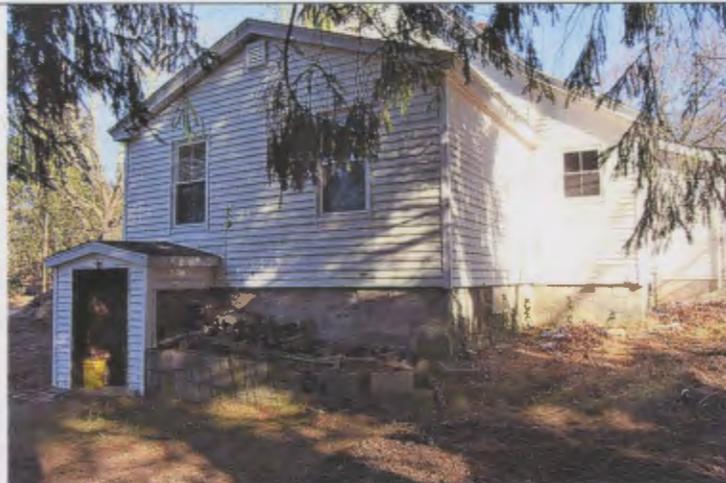
View looking north-northeast toward west ell and basement entrance. The small window at right is the west elevation of the small, shed-roof projection attached to rear elevation.

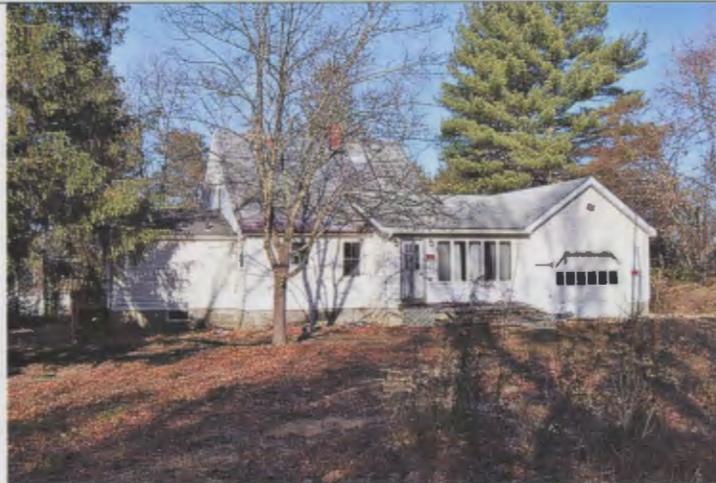
View looking northeast toward rear elevation. The two windows at left are located in the rear elevation of the small, shed-roof projection.

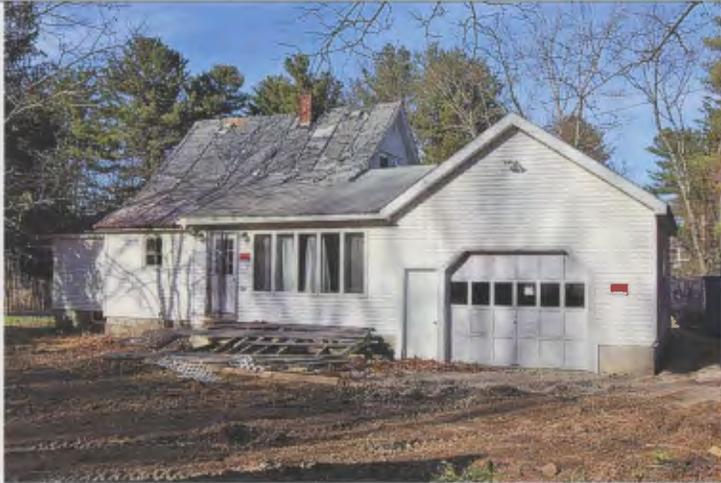
View looking northwest toward rear elevation. Collapsed porch at center by rear doorway. The casement windows and door are part of the garage addition.

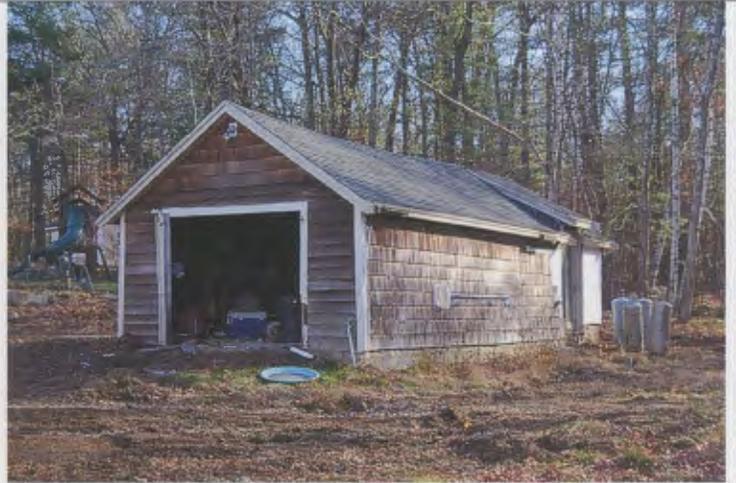
View looking southeast toward north (left) and west (right) elevations.

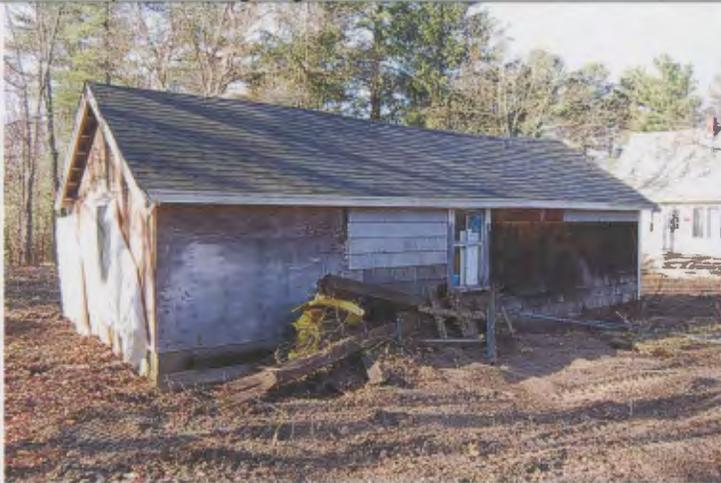
A detached garage is located southeast of the house. The garage rests on an uncoursed, roughly-cut stone foundation and is capped with a gable roof with overhanging eaves. The garage is sheathed with wood shingles (on the side elevations) and clapboards (on the north elevation) over tongue-and-groove wood bead boards. A vehicle opening fills the north elevation. A single 2/2 wood-frame window is located in the east elevation. The garage was expanded by approximately 1/3 its size in the late 20th or early 21st century. The expansion rests on a concrete block foundation and is sheathed with plywood. A side-hung, full-light, metal door is located in the south end of the east elevation.

View looking northwest toward east elevation (right) and south elevation (left) of garage.

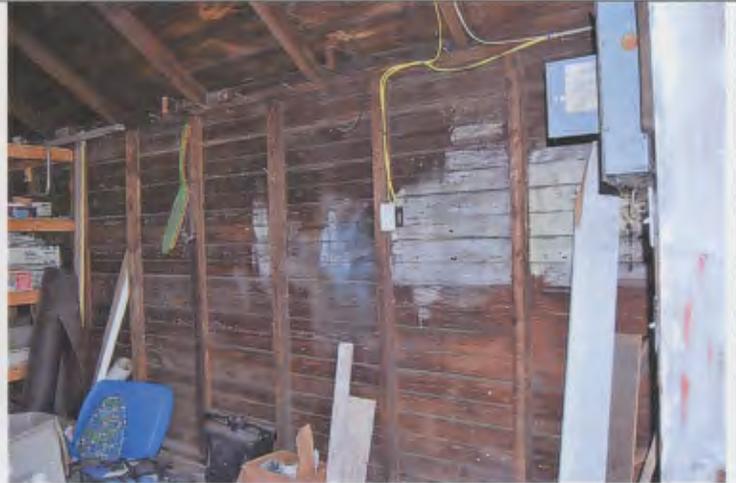
Garage interior showing bead board walls.
