## FORM B – BUILDING

209 Main Street

Historic Name:	Rev. Samuel H. and Isadora Virgin House

CLM.366

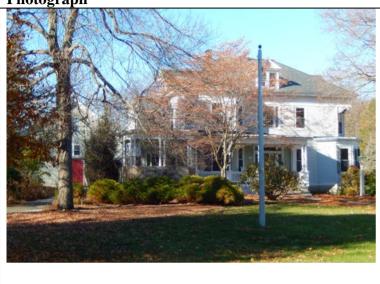
#### **Photograph**

**Major Alterations** (*with dates*): Ca. 2000 replacement siding and windows

Condition: Fair

The 2.5-story house has a stone foundation, walls clad in replacement vinyl siding with wood trim, and an asphalt-shingled hipped roof. One internal brick chimney is located along the rear slope of the roof. Single dormers with double windows and pediments are centrally located on the slopes of the primary (southeast) façade and the southwest and northeast walls. Most windows throughout the building are replacement, one-over-one, double-hung windows with wood surrounds. A dentil molded cornice with a wide friezeboard runs along the perimeter of the building. The primary façade is three bays wide. The south bay features a two-story bay window and the north bay of both stories features single windows. The center bay of the first story includes the main entry that features sidelights and a transom. A porch wraps around from the south two bays of the primary façade to the southwest wall. The porch has a slightly pitched roof supported by paired piers. The porch has wood railings along the primary façade and a solid stone railing at the south corner.
