# FORM B – BUILDING

**Town/City:** Chelmsford

**Address:** 8 Middlesex Street

**Historic Name:** Adams House Hotel

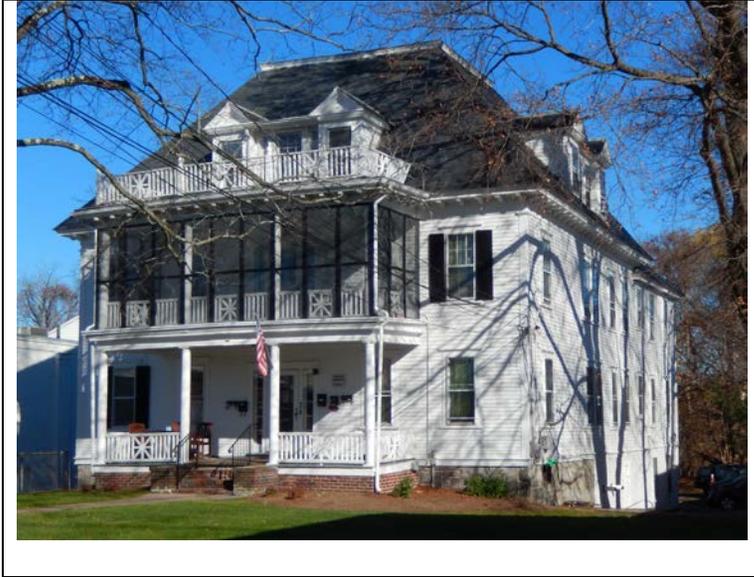
## Photograph

**Condition:** Good

The 2.5 story building has a stone foundation, an asphalt-shingled steeply-pitched hipped roof, and is clad in wood siding with wood trim. The roof line has a bracketed overhanging eave. The main mass of the building measures approximately 40' by 40' with two rear wings that each measure approximately 30' long by 20' wide. The wings were added to the building ca. 1920. Windows throughout the building are replacement, one-over-one, double-hung sash windows. The primary (south) façade is five symmetrical bays wide with single windows in the outer bays. Entry doors are located in the center bays of the first and second stories. Both doors feature narrow sidelights and modern storm doors. A three bay dormer is located on the half story. The dormer features single windows in the outer bays that are topped with pediment gables, and an entry door is in the center bay. A two-story porch is located across the center three bays of the primary façade. The porch features a brick foundation, round Doric columns on the first and second stories, and wood railings on all three stories. The porch on the second story appears to be temporarily enclosed with screening. The east and west walls of the main mass of the building are four bays deep with single windows in the north two bays and the south bay with paired windows in the other bay. These walls also feature dormers like that of the primary façade. The rear (north) wall includes a single bay, rear gable dormer. The rear wings are three bays deep with single windows in these bays.
